CULTURAL RESOURCES SURVEY

LONG BRANCH LAKE

Macon County, Missouri

HISTORIC ARCHITECTURAL RESOURCES

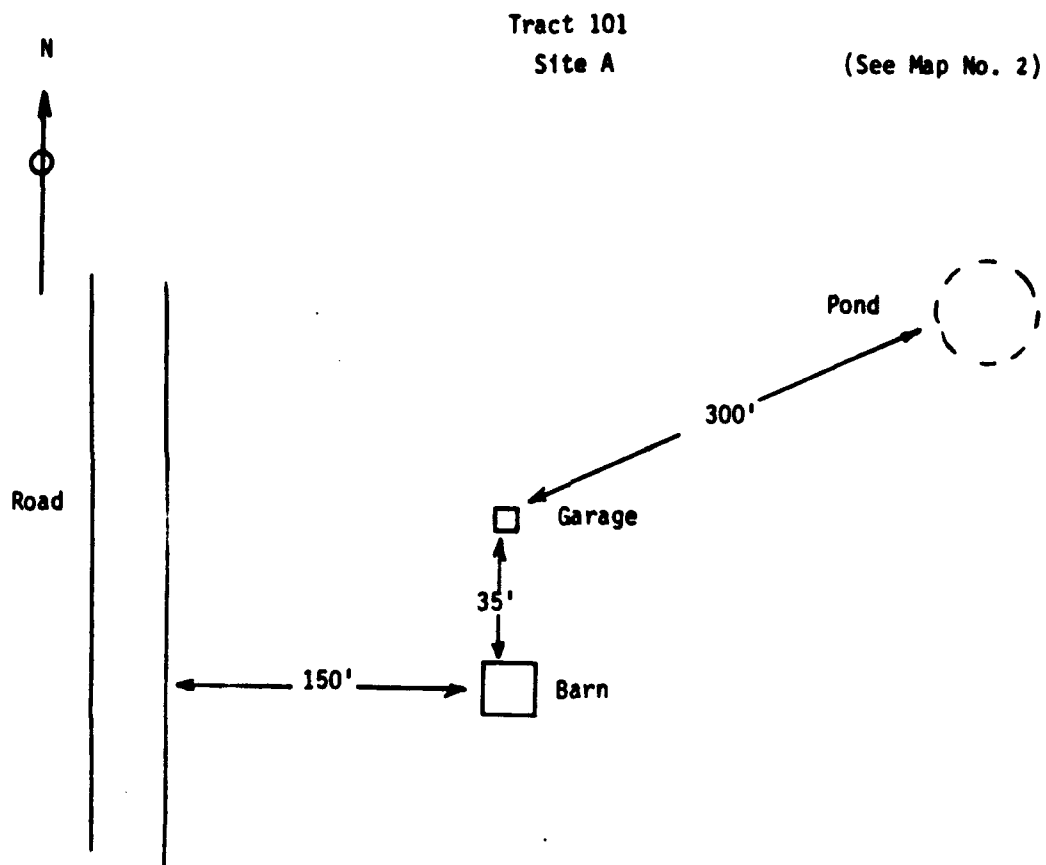
This barn was nearly square, and perhaps the most unremarkable barn examined on the Project. Regular in every way, it symbolized the functional, no-nonsense barn of the 30's, when the small farmer was still a major force in the agriculture of the region. It had been wired for electricity early, with knob-and-tube wiring which, in turn, had been replaced by more modern romex wiring. The siding was plain "barn boards" and the roof was of corrugated metal.

Front of barn

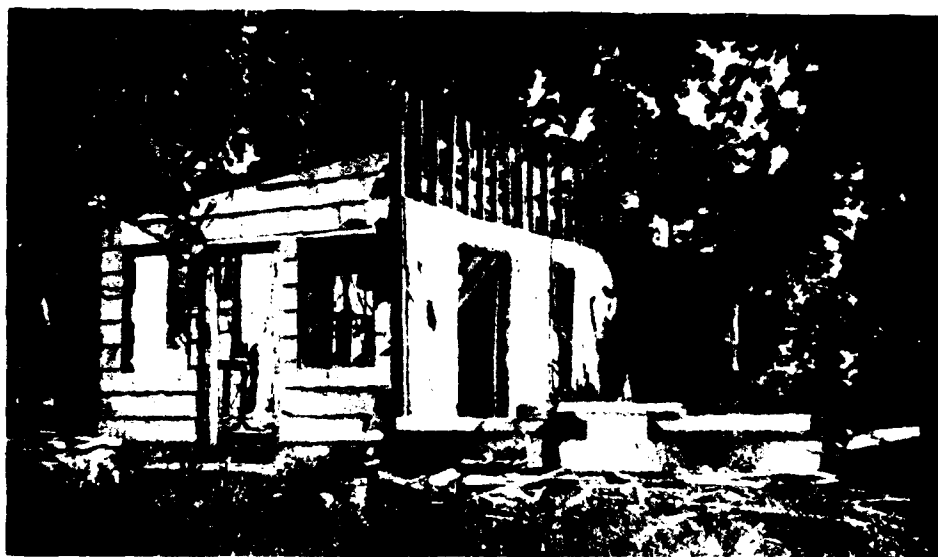
The house on Tract 105 A had been partially dismantled, and some of its lumber retrieved by the owner. What remained at the time of inspection showed the typical balloon frame construction, with lath and plaster walls.

Remains of house, facing North-northwest

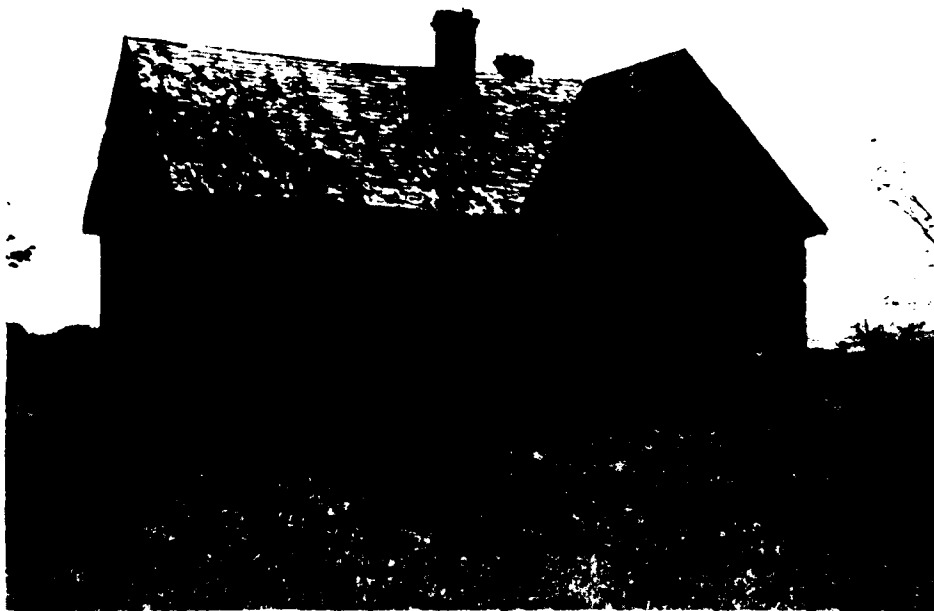
The house had not been painted in many decades. It had certainly been abandoned for several years, and much damage had occurred in that time. Boards had been ripped off, exposing details of the builder's technique. Several features are worth reporting.

North side of house

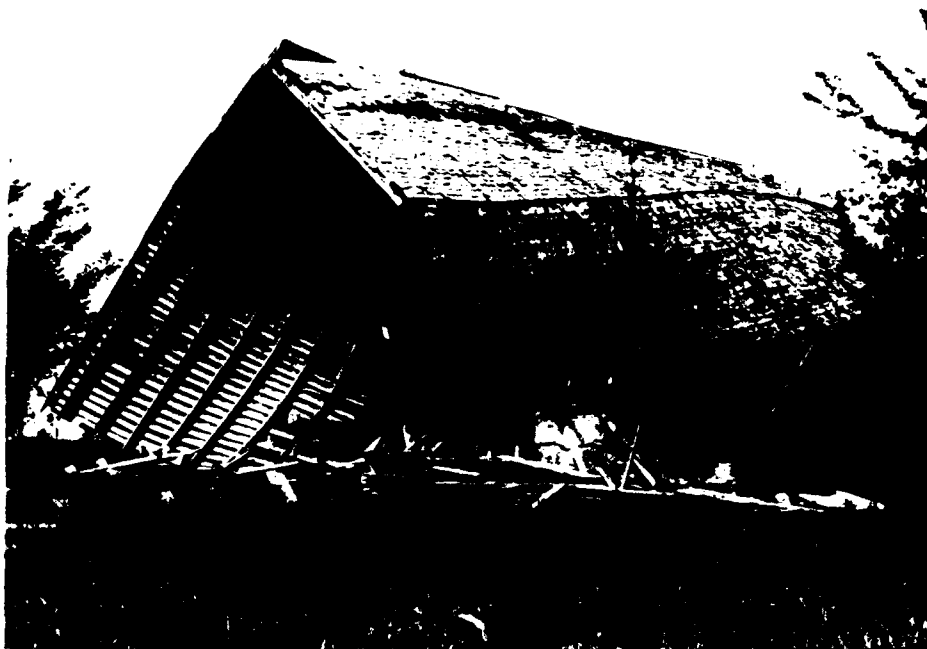
the custom of bracing the gambrel angle with a long spar, as shown at the left. The resultant triangle is so flat as to offer little rigidity, so that the roof tends to sag under the weight of snow, and with age.

Collapsed barn roof, facing Southwest

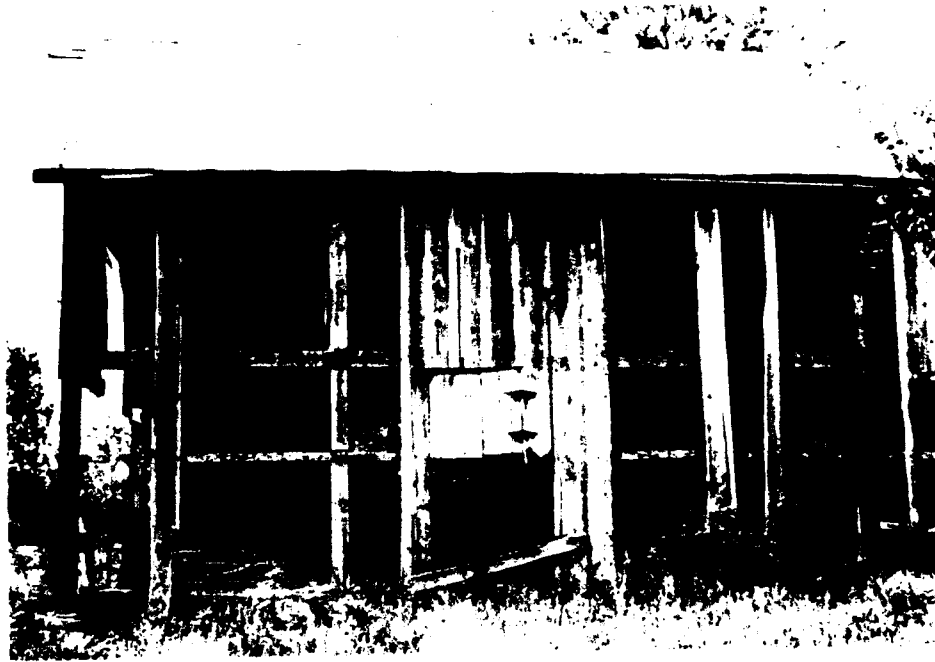
When observed, the barn was still upright and sturdy but many of the side boards and battens had been stripped off, preparatory to dismantling. The barn roof was shingled

The west section of the barn, viewer facing North

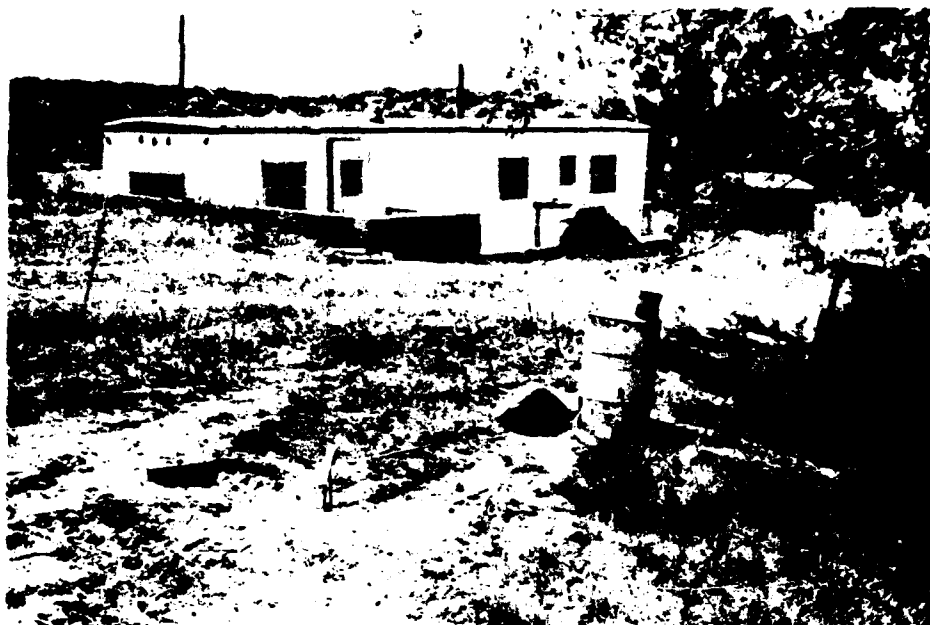
Remains of foundations on site. Trailer used by Army Corps of Engineers. Viewer facing Southeast
